GEO-ENVIRONMENTAL ASSESSMENT
PRINCES PARADE
HYTHE, KENT
SHEPWAY DISTRICT COUNCIL
GEA-17436AI-15-193 REV B
OCTOBER 2015

Rev	Date	Author	Checked	Approved
B	16/10/15	CJM	KRP	RJG

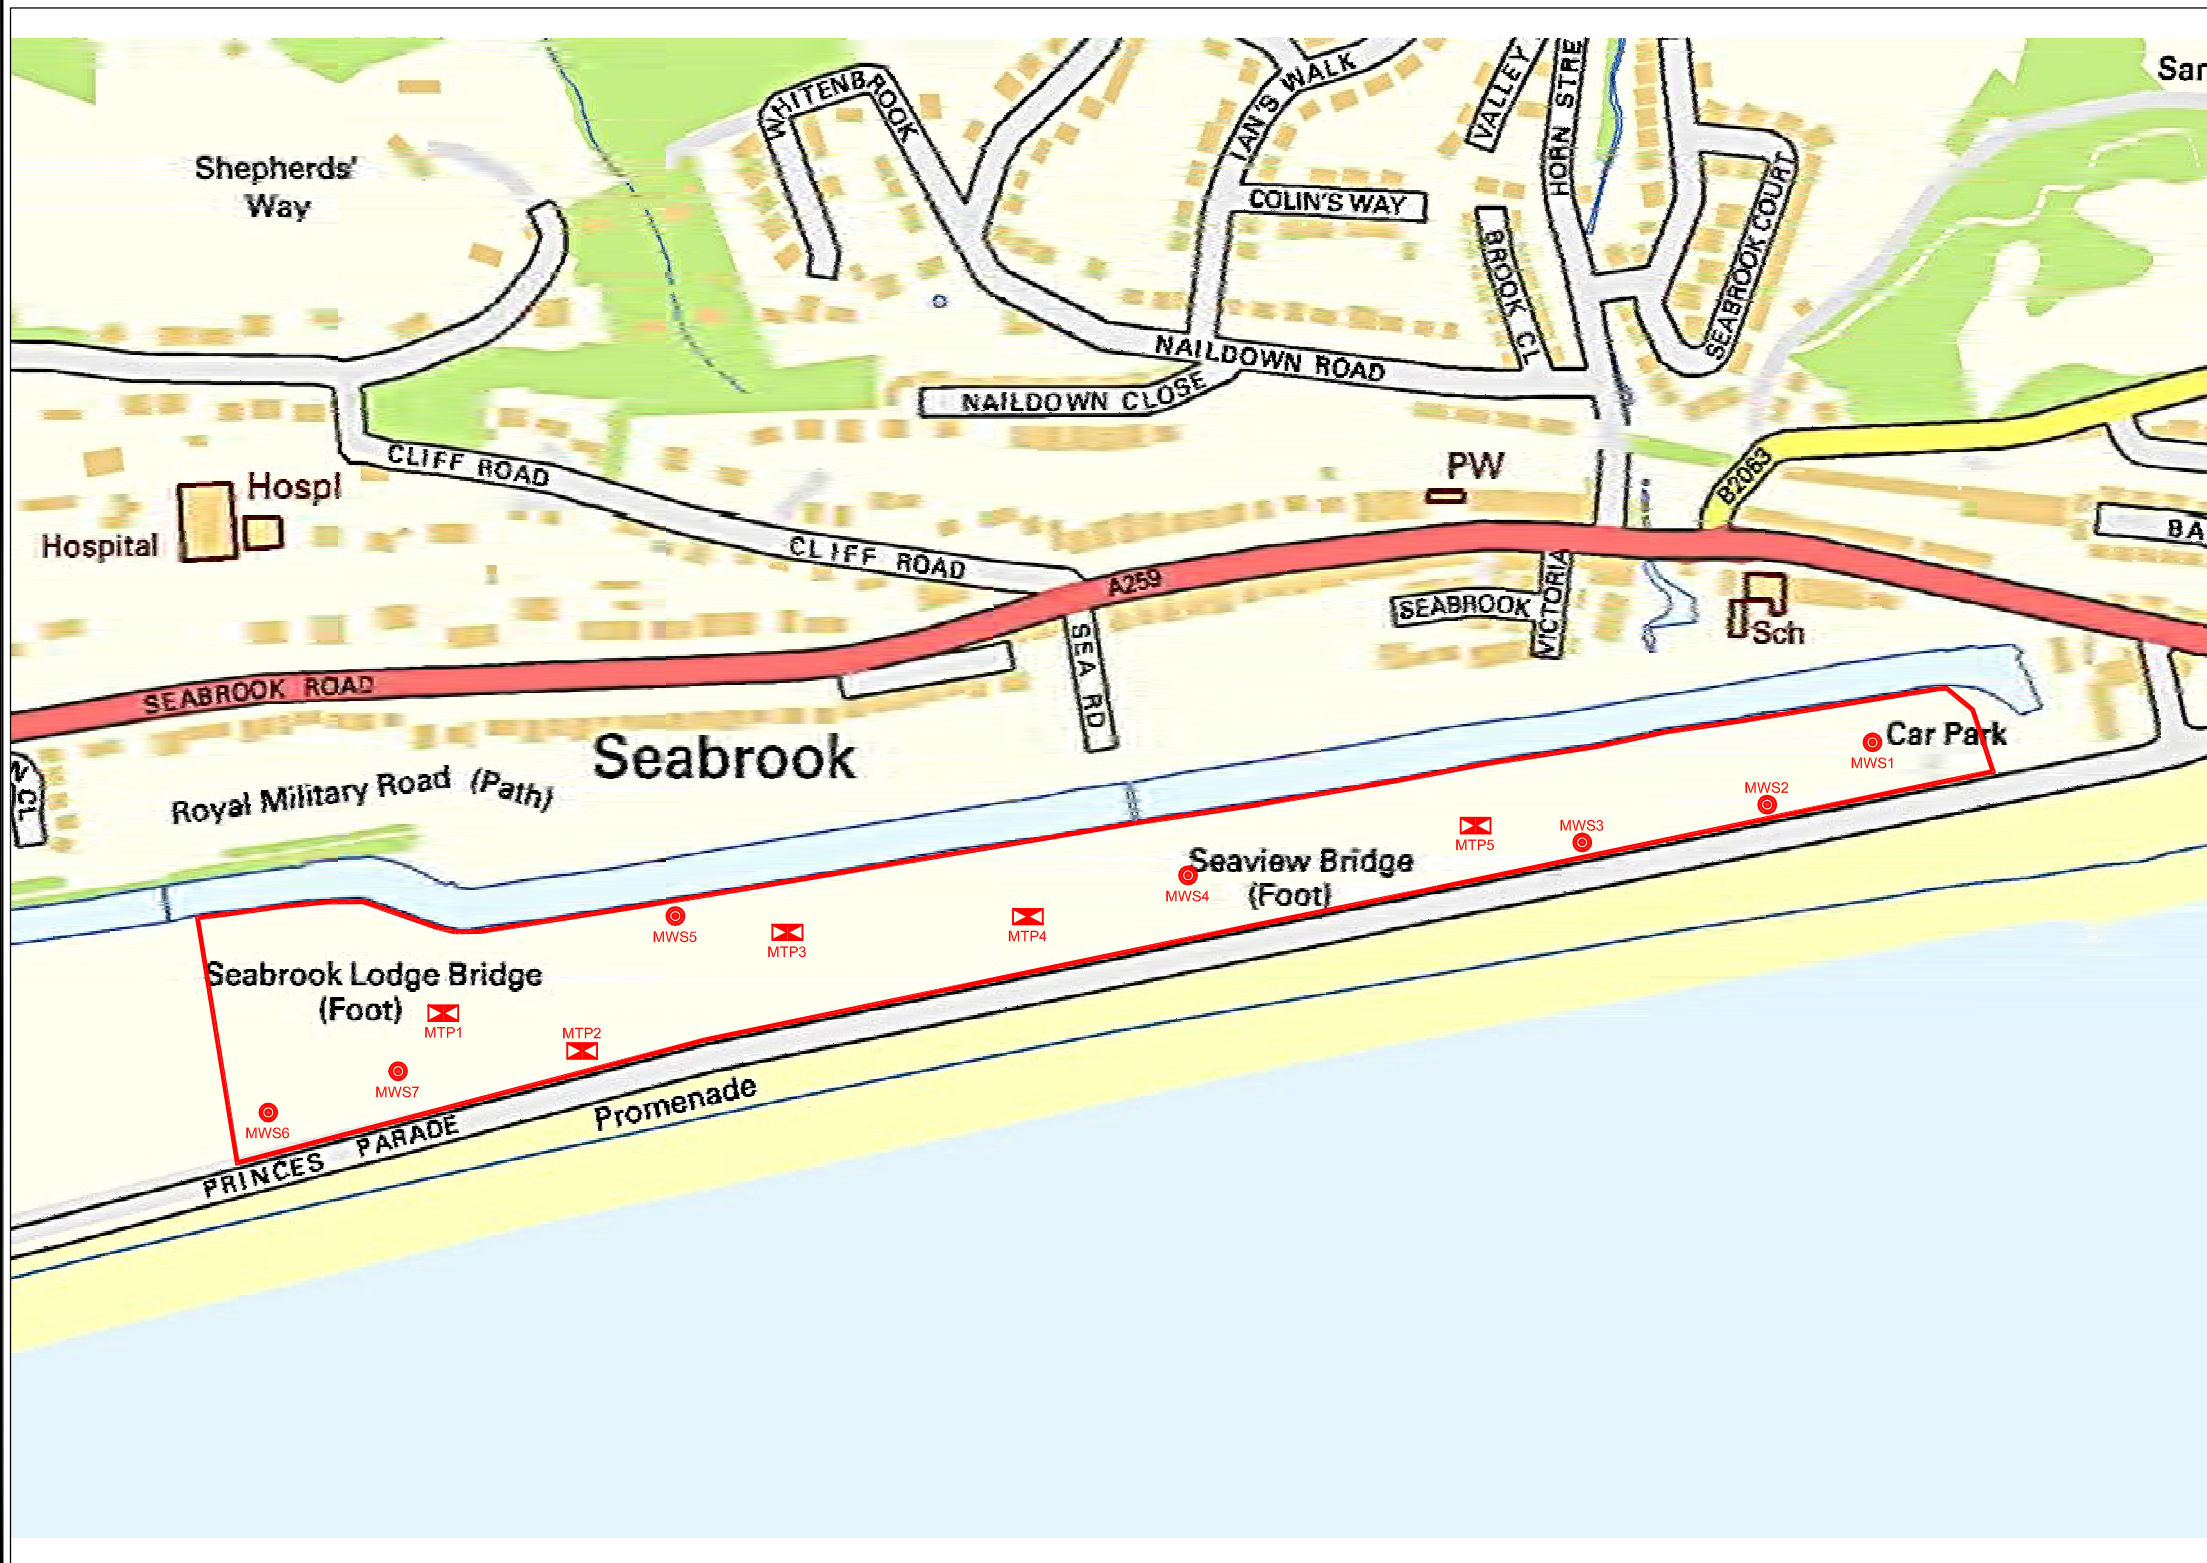
- Site boundary
- ✕ MTPref Merebrook trial pit with location reference
- MWSref Merebrook window sample with location reference
