Shepway District Council

Proposed Leisure Centre and
Mixed-Use Development at
Princes Parade
Hythe

Environmental Statement
Technical Annex 5
Geo-Environment

GEO-ENVIRONMENTAL ASSESSMENT
PRINCES PARADE
HYTHE, KENT
SHEPWAY DISTRICT COUNCIL
GEA-17436AI-15-193
MAY 2017

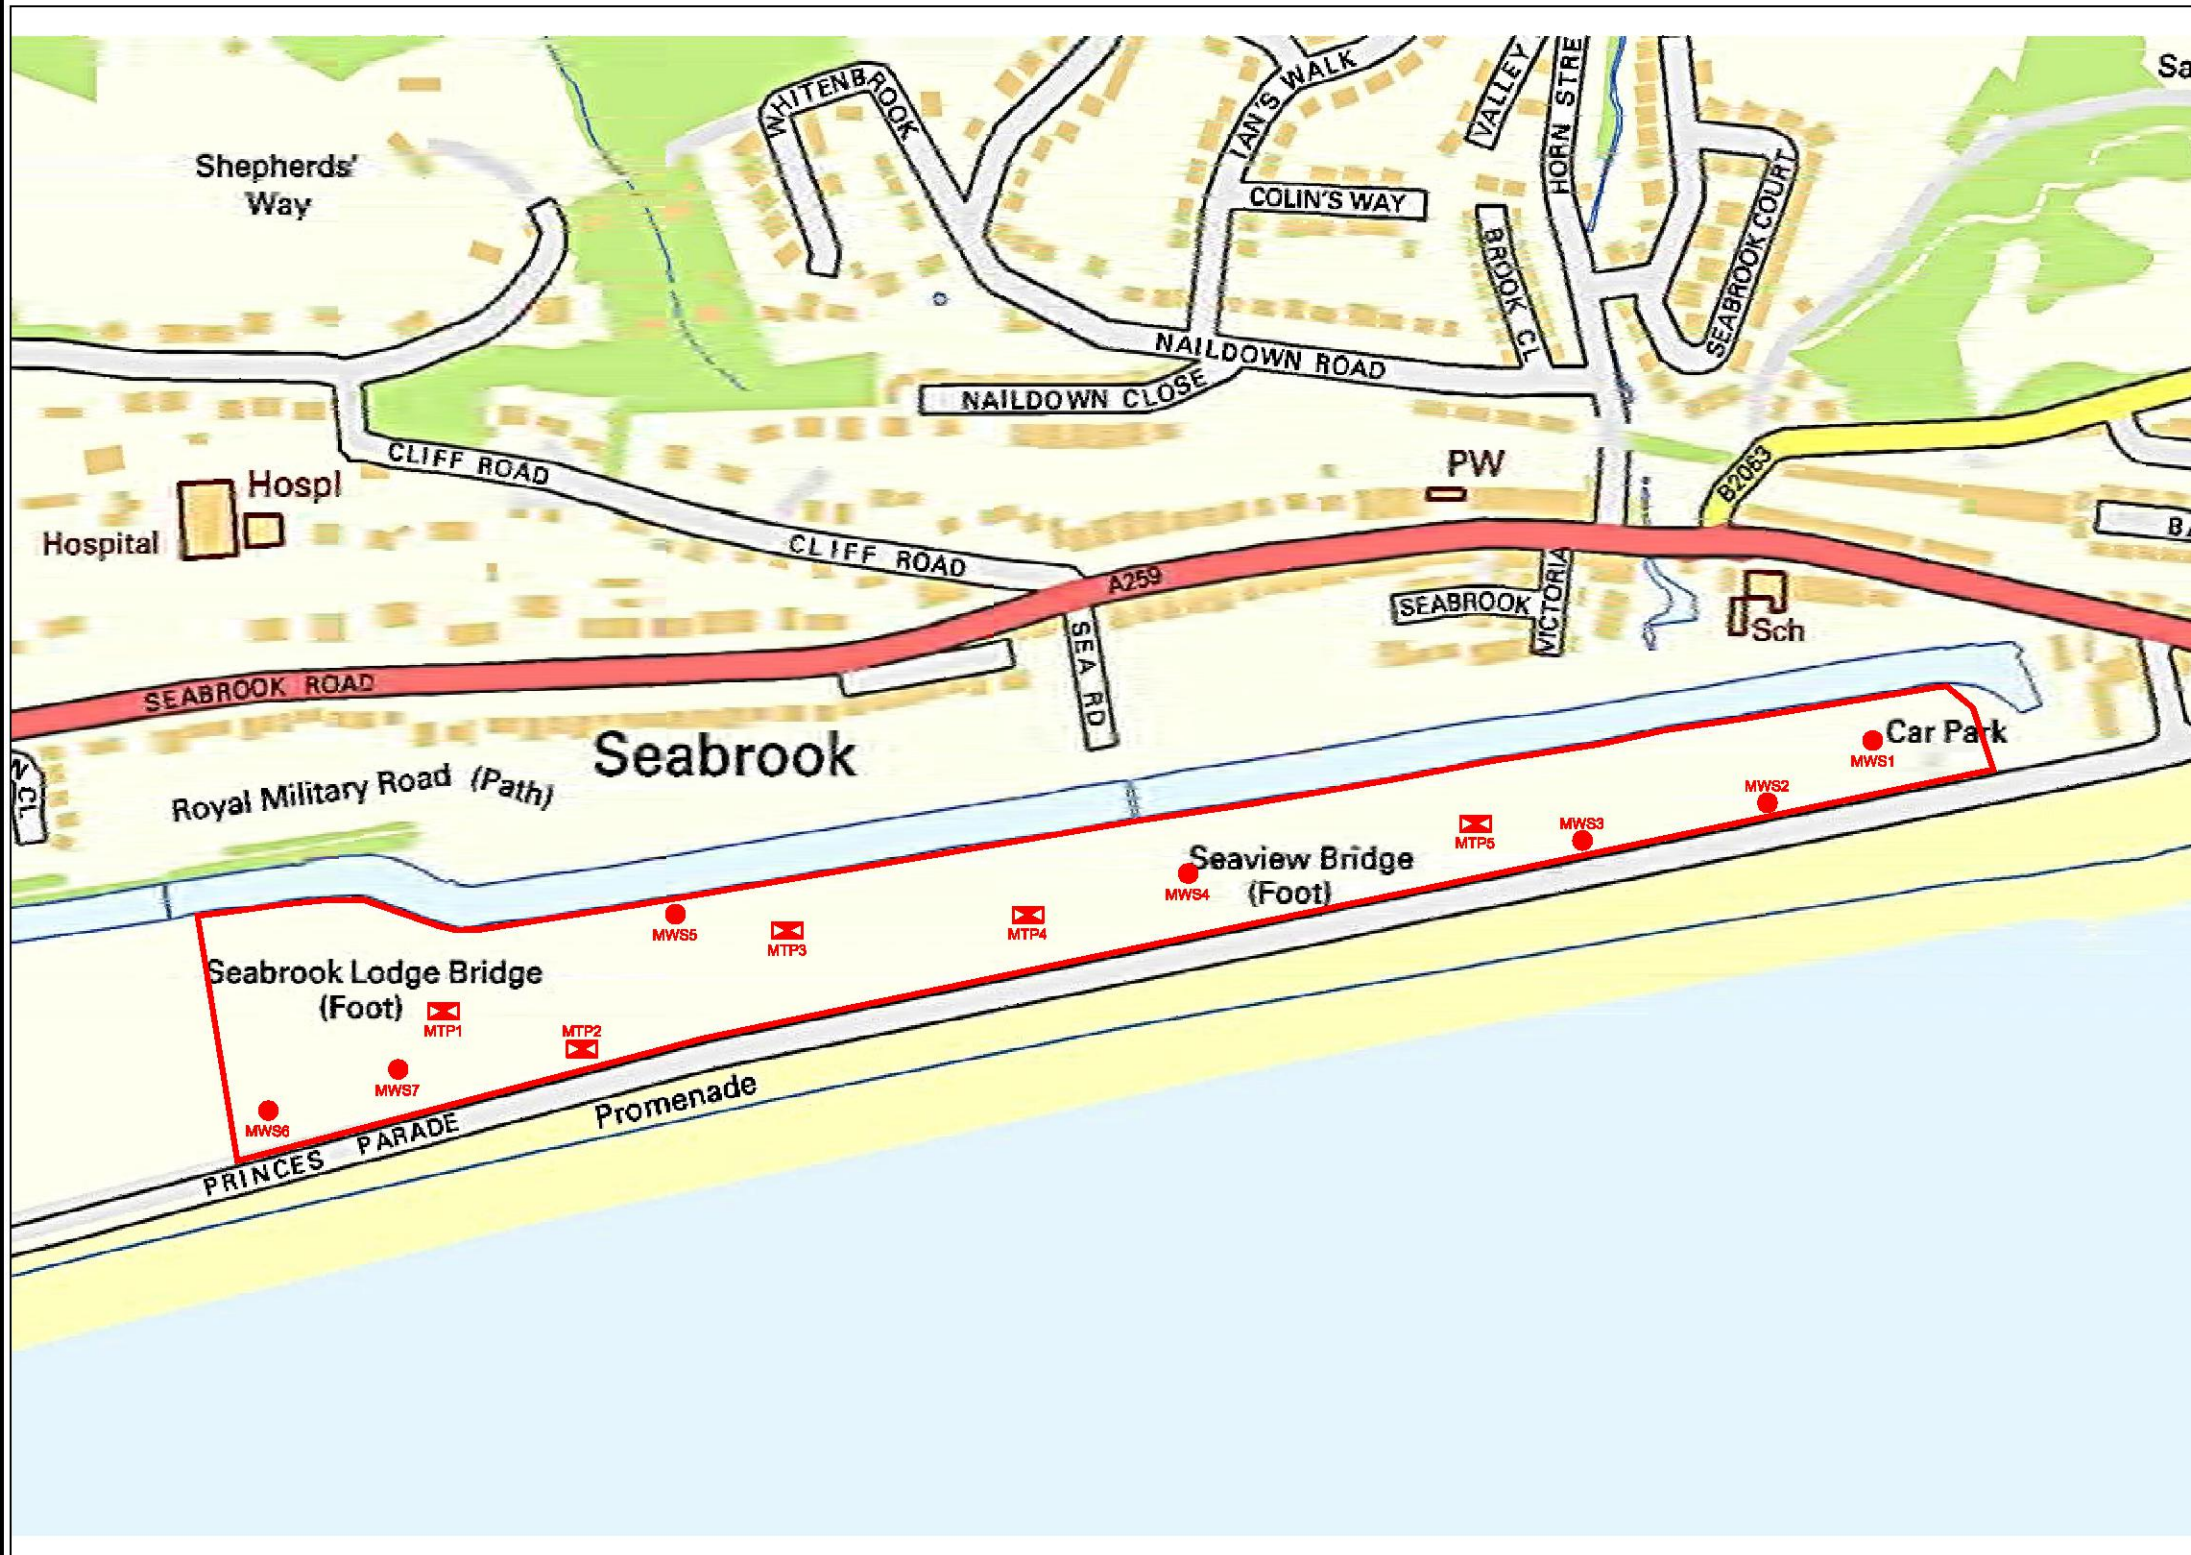
APPENDIX 1 ▪ Drawings

- Site boundary
- ✚ MTPref Merebrook trial pit with location reference
- MWSref Merebrook window sample with location reference

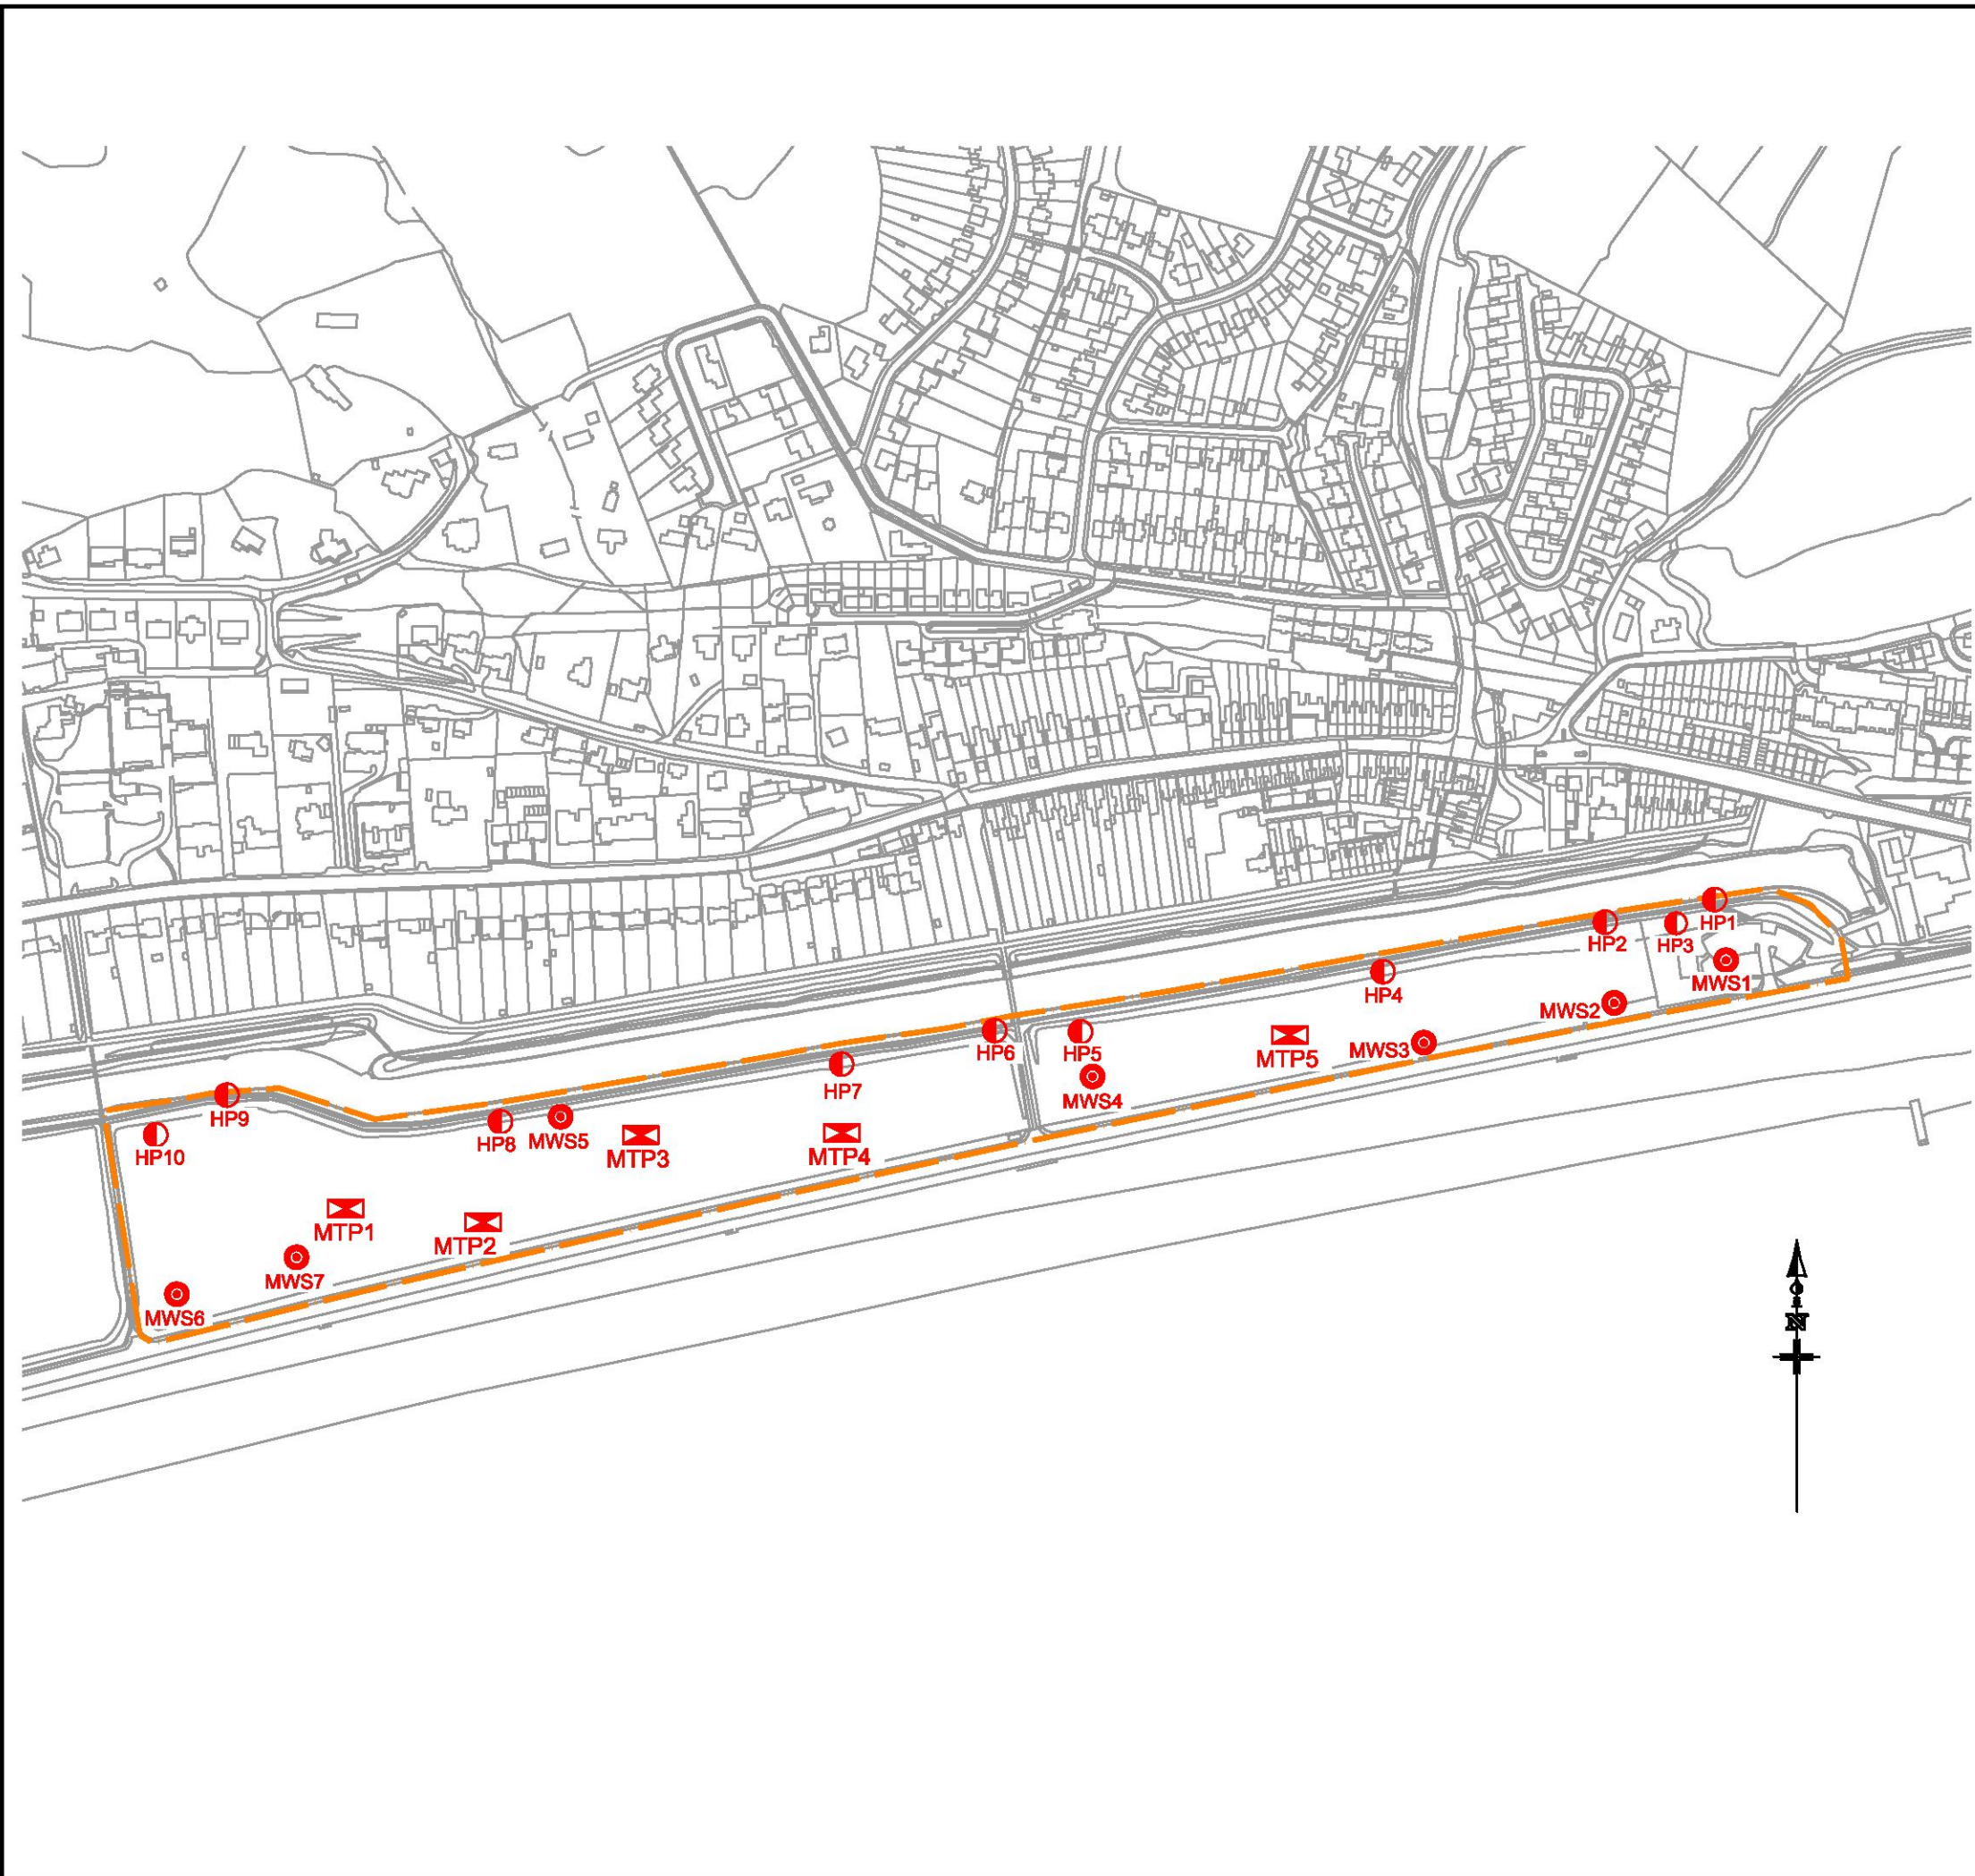
- Legend**
- - - Approximate Site Boundary
 - **MHAref** Approximate Merebrook hand auger location with reference (Feb 2017)
 - ⊖ **MWSref** Approximate Merebrook window sample location with reference (July 2015)
 - ⊠ **MTPref** Approximate Merebrook trial pit location with reference (July 2015)
